14th INTERNATIONAL FLEXIBLE PAVEMENTS CONFERENCE

TYPICAL CAUSES AND SOLUTIONS TO BLEEDING SEAL COATS

Walter Holtrop – National Surfacing Engineer, AAPA

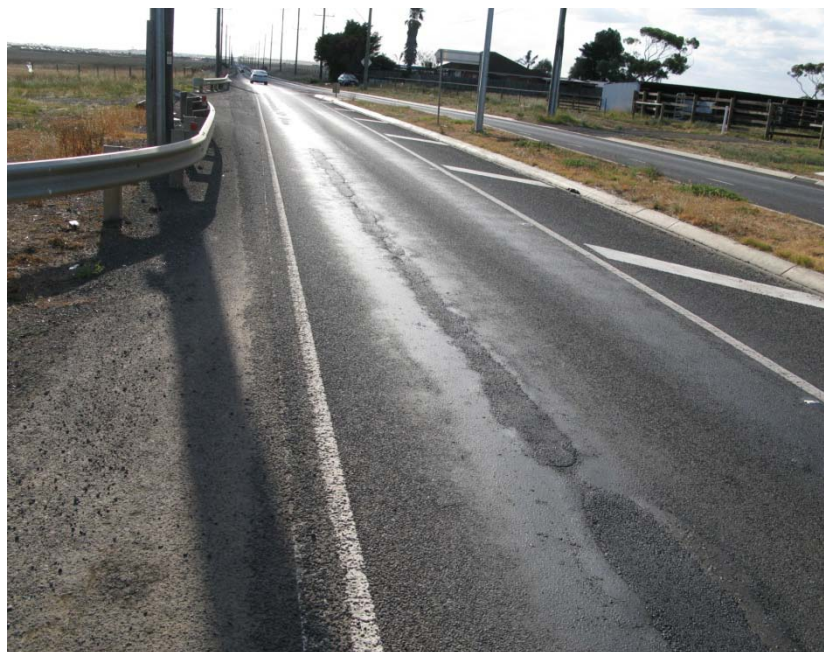
At age two years this "bleeding" seal had minimal texture. On a very hot summer's day the binder became very tacky and picked up resulting in damage to the seal. At this stage this damaged seal has been repaired with cold mix, but needs major repair prior to resurfacing. We should ask ourselves three simple questions:

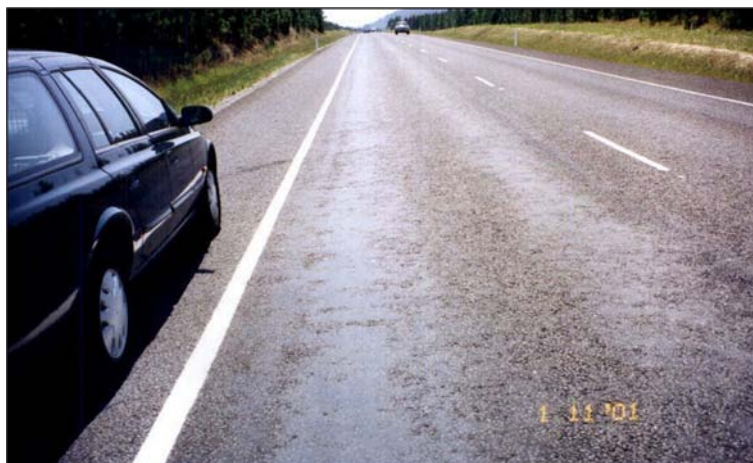
Loss of texture due to embedment of aggregate on new work where the pavement was not given sufficient time to cure. This may be prevented by:

- Adopting sound construction practices and achieve compaction
- Allowing pavement to dryback
- Checking potential embedment with embedment hammer (see section on Seal Design)
- Avoiding applying treatment in cold/wet conditions

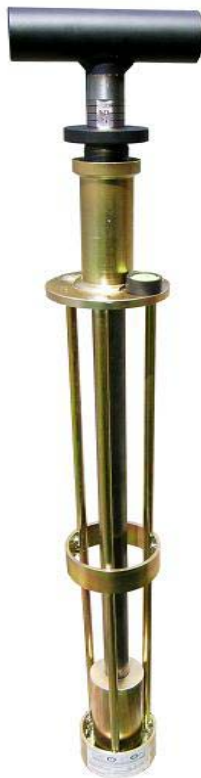
To determine potential embedment of aggregate on new granular pavements prepared for sealing we have adopted using the Modified Ball Penetrometer test, generally referred to as the 'ball embedment' hammer. The Austroads design is based on the original Republic of South Africa (RSA) concept and we have an arrangement to compare results with RSA with a view to further development and use of this test on assessing potential embedment when sealing over other surfacing such as say asphalt regulation.

The test is used:

- After compaction and dry back prior to priming/primersealing
- On primed surfaces prior to sealing

Recommended limits are:

- Ideally: 3mm or less
- Maximum: 4mm

If embedment is greater than 4mm consider the following options to minimise the risk of bleeding in the wheel paths:

- Allow more time for dry back
- Select an alternative treatment, say smaller aggregate primerseal or inverted seal
- If possible – defer the work

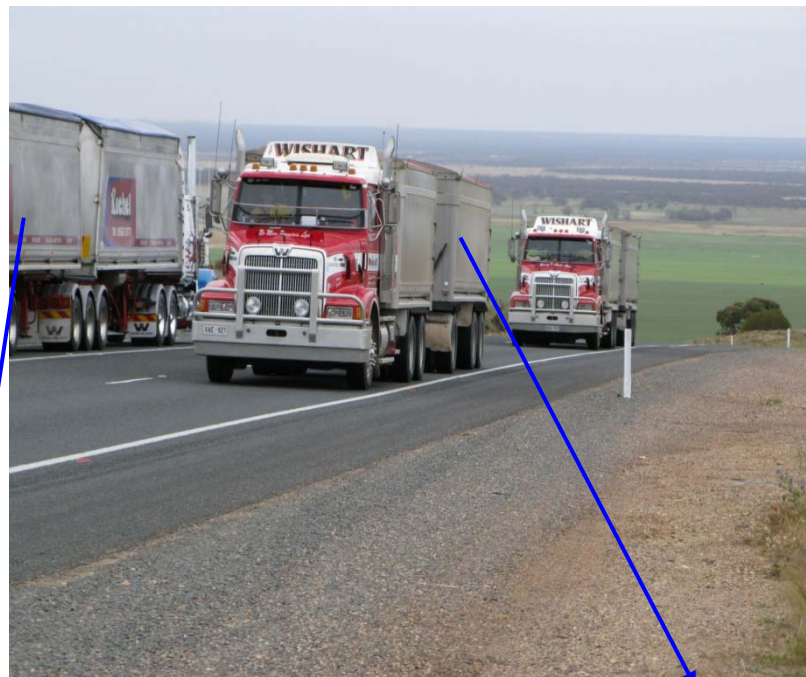
Large heavy vehicle (9 axles)

B-Double

Heavy vehicle (6 axles)

Truck-trailer combination

From practical observations and statistical analysis of traffic data relating to heavy and large heavy vehicles, it was concluded that large heavy vehicles have about three (3) times the effect of normal heavy vehicles.

EHV = (HV) + (3xLHV) % as part of the Design Traffic.

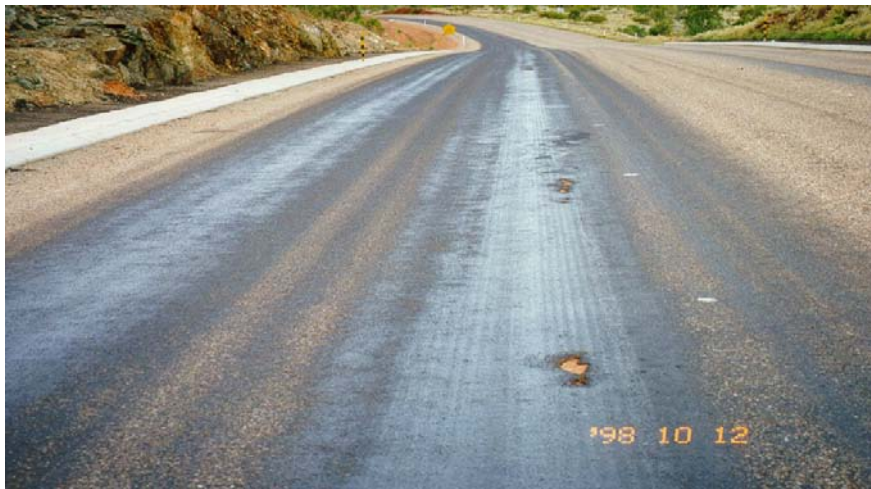
An unsatisfactory Final HSS Seal constructed using a PMB as part of the treatment. HV and LHV not considered adequately, plus incorrect PMB Factor, leading to early bleeding and pick-up of the binder. The major problem now is how to correct this to achieve a satisfactory long life sprayed seal surfacing.

The PMB Factors range from a Factor of 1.0 (HSS) to as high as 1.3-1.4 (SAM). If say the SAM Factor is used for a HSS design this could result in a design with an excess of up to 30% of binder for the conditions.

It is therefore very important that the designer determines WHY the PMB is used and which type and grade of PMB in order to determine the correct PMB Factor for the design.

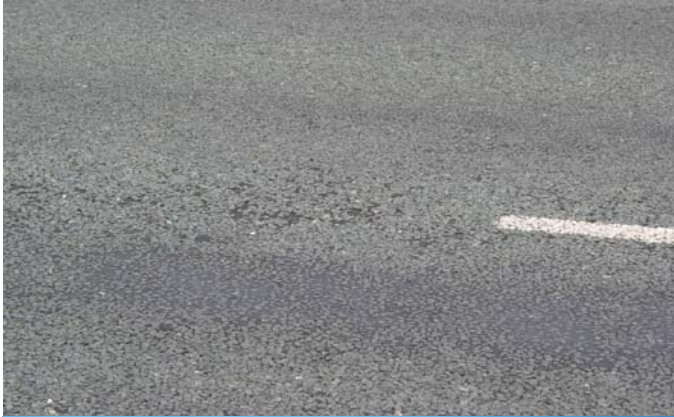
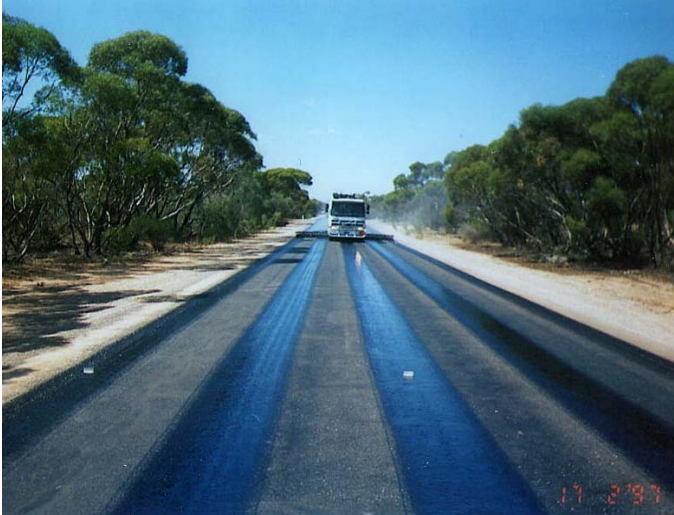
Variable surface texture on road planned to be resealed. Difference in binder design rate averages 0.4 L/m² from wheel paths to coarse textured areas

Option selected was to apply variable spray rates across the pavement surface

Note binder applied in coarse textured areas only on the first run at 0.4L/m²

Sprayer is returning immediately on 2nd run at full width, spraying at design binder rate of 1.0L/m² for wheel paths.

Job is then covered with aggregate and rolled as normal

- Apply a correction seal or micro-surfacing prior to resealing
- Spray different rates of application across the pavement. This can be done using a single sprayer doing 2 runs, 2 sprayers following each other or using a sprayer designed specifically to be able to apply variable transverse rates of application.

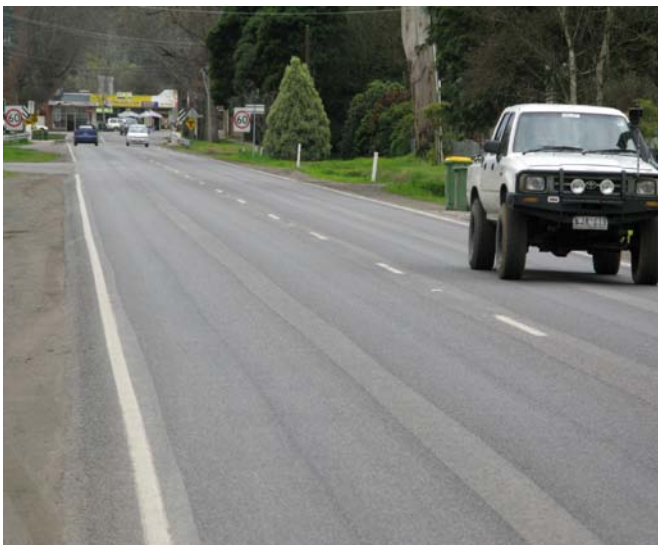
An example of texture restored in wheel paths of a road carrying medium traffic volume, with about 10% heavy vehicles and very few large heavy vehicles

Age of water blasting: over 2 years since surfacing was water blasted and still has adequate texture and is not expected to require any further treatment for at least another couple of years

Special high pressure water blasting equipment has proven to be able to successfully remove excess binder from a bleeding or flushed seal to restore texture. Similarly shot blasting may be used but the binder to be removed must be relatively hard for this to work effectively.

The aim is to restore surface texture to about 1 to 1.5mm depending on the aggregate size.
