The influence of asphalt workmanship on pavement service life

Joralf Aurstad^{1, a}, Nils S. Uthus^{1, b}, Roar Telle^{2, c}, Leif J. Bakløkk^{1, d}

¹ Norwegian Public Roads Administration, Trondheim, Norway

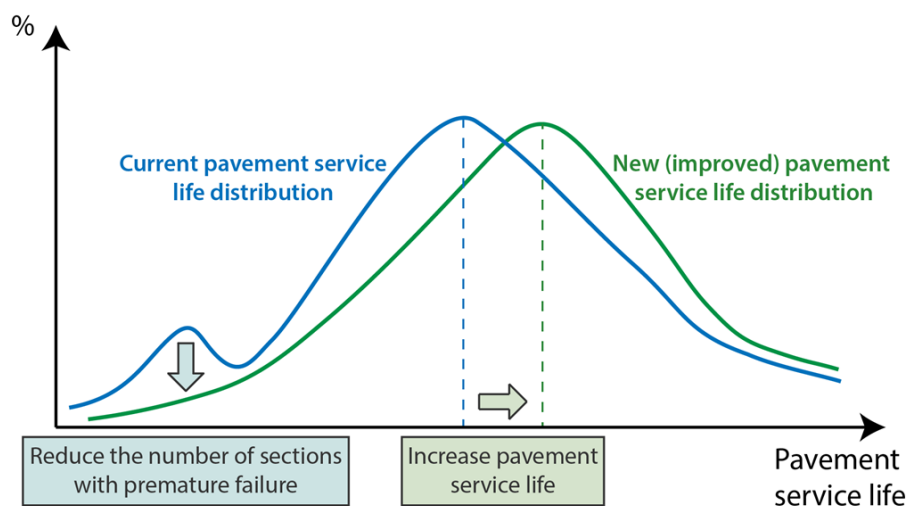
Figure 1: Asphalt pavement life distribution, effects of cutting early failures.

Premature pavement failures/distresses occur too often, as shown on figure 1. Focus on cost and completion time often leads to low quality work and improper use of materials.

If these early distresses can be avoided (eliminating the "bump" to the left on the figure), the overall pavement life will be substantially increased, moving the entire curve to the right. Even in a relatively small country like Norway, this represents a lot of money (see chapter 4).

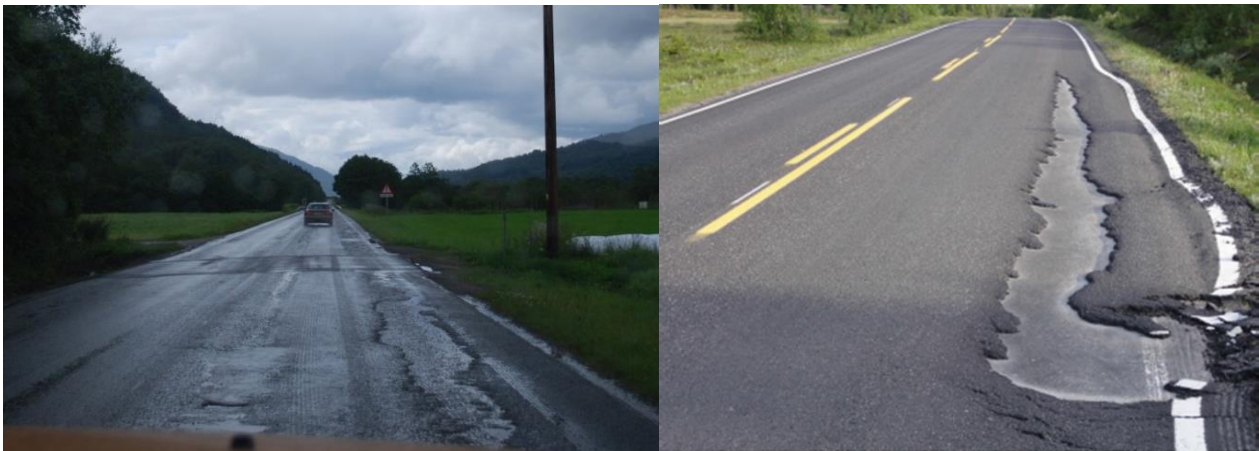
Figure 2: Typical asphalt pavement failures caused by poor interlayer bonding.

Typical problems are lack of bonding between asphalt layers, poor longitudinal and transverse joints and inhomogeneity, as shown in figures 2-4.

In Norway only bitumen emulsions are used as tack coat materials. These materials are often described in the tender documents by type and required dosing, but in most cases, these are “dormant requirements”. In reality, there is hardly any documentation and control system to ensure bonding quality.

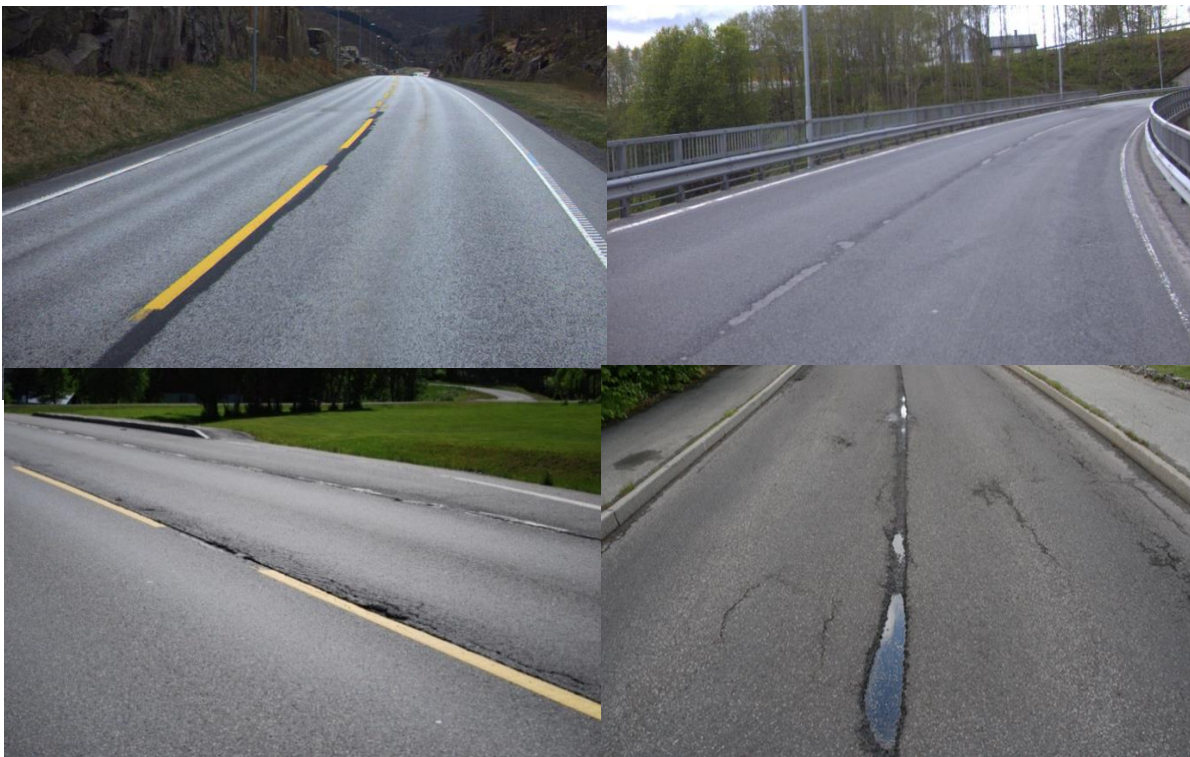
Figure 3: Typical asphalt pavement distresses due to improper execution of longitudinal joints.

Joints are often the weakest and most vulnerable areas on asphalt pavements in Norway. High void content due to improper bonding and/or mix separation will allow water to penetrate into and under the asphalt. And combined with traffic pumping and freeze-thaw mechanisms, the pavement soon will start to deteriorate. These open joints will not only cause low driving comfort and reduced pavement life, in some cases this is clearly also a safety problem.

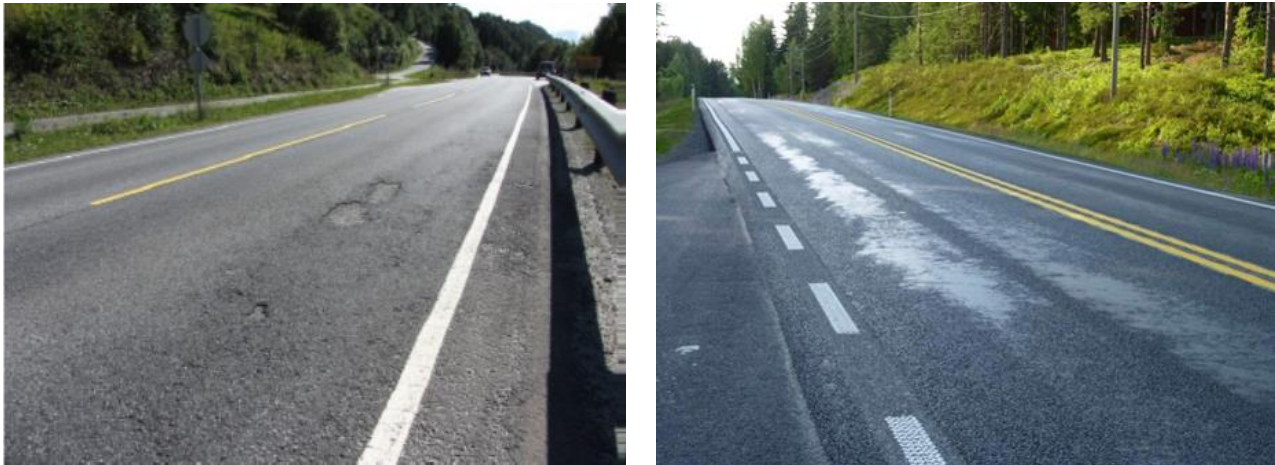
Figure 4: Typical asphalt pavement inhomogeneities (mix segregation, open vs. dense areas), these may cause both durability and poor friction problems.

areas with only coarse aggregates will soon deteriorate, as showed in figure 4. But dense areas are even worse with bitumen overfilled voids leading to “bleeding”, which can be dangerous spots regarding wet friction.

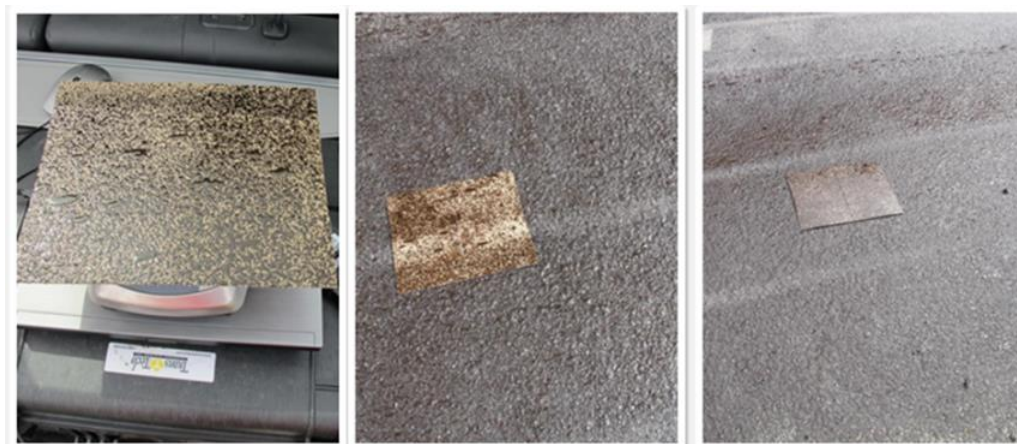
Figure 5: Pads used for measuring tack coat (emulsion) application rates.

Thus, a number of repaving projects was investigated in the project. The spraying of emulsion was controlled by laying out pads before application. By visual inspections, and by weighing the pads before and after, both the tack coat distribution and the amount spread (weight/m²) could be determined, as shown in figures 5 and 6.

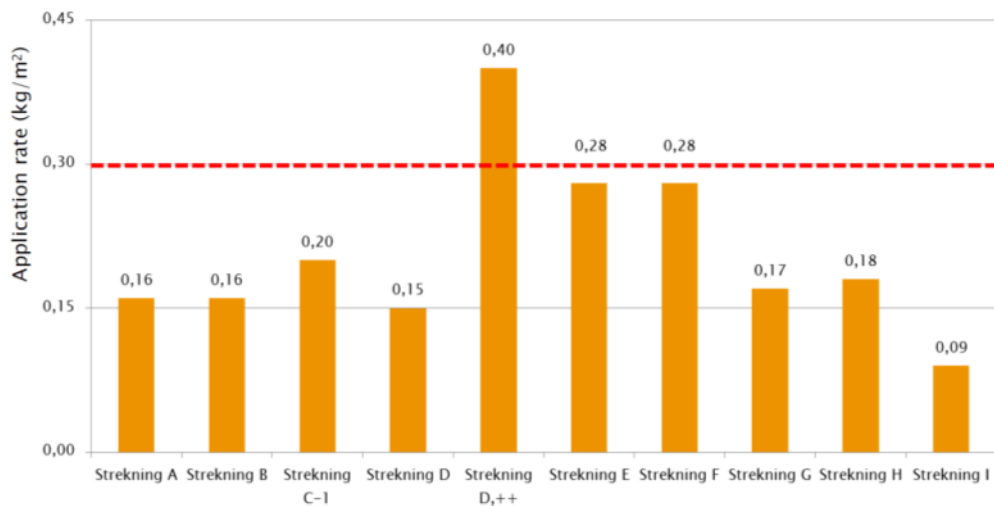
Figure 6: Amount of bonding bitumen measured on ten different road sections (dotted line indicates requirement 0,30 kg/m² bitumen emulsion left on surface).

As seen from figure 6, only one out of ten investigated sites showed tack coating in compliance with NPRA’s requirements. These results have caused the introduction of more stringent descriptions in the tender documents. The specifications are now changed from 0,30 kg *bitumen emulsion* per m² to 0,15 kg *bitumen* per m². This is due to the fact that one single type of emulsion may show considerable variations in concentration, because of storage conditions etc. and it is difficult to measure the quantity of applied emulsion precisely as some of the water is lost during spraying.

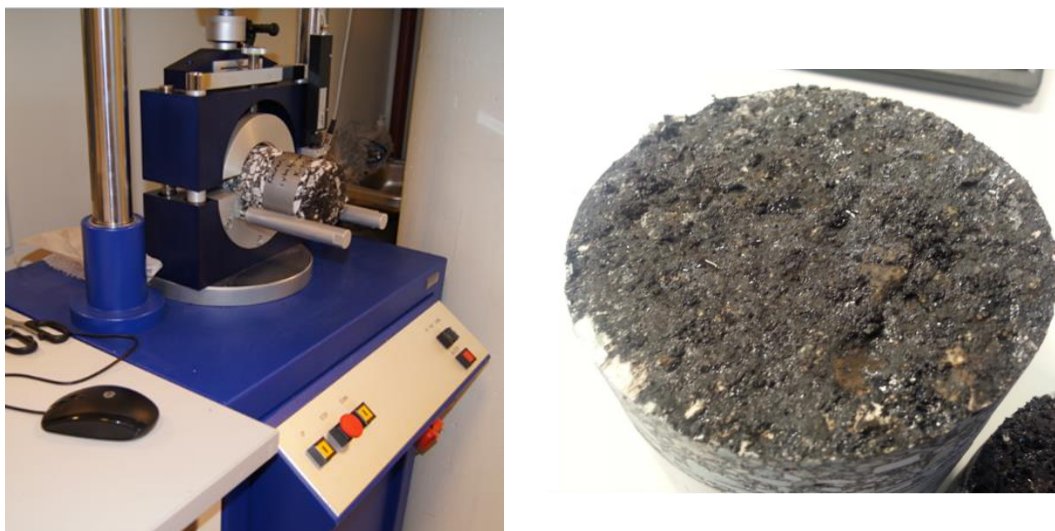
Figure 7: Shear bond test (EN 12697-48). Tested specimen; poor bonding caused by wet and dirty surface.

However, resulting bonding not only has to do with the amount of emulsion sprayed on the old asphalt surface. Many factors will influence on the bonding properties; rain/water on the road surface, contaminants/dust, temperature, type of asphalt materials and so on. Therefore, NPRA now wants to move towards more functional requirements, also regarding asphalt bonding. Then it will be more up to the contractor to choose the right type and amount of binder. One task has been to investigate a new method (at least in Norway) for physical testing/measurement of the bonding, as shown in figure 7. This is discussed in a separate report from the project [3].

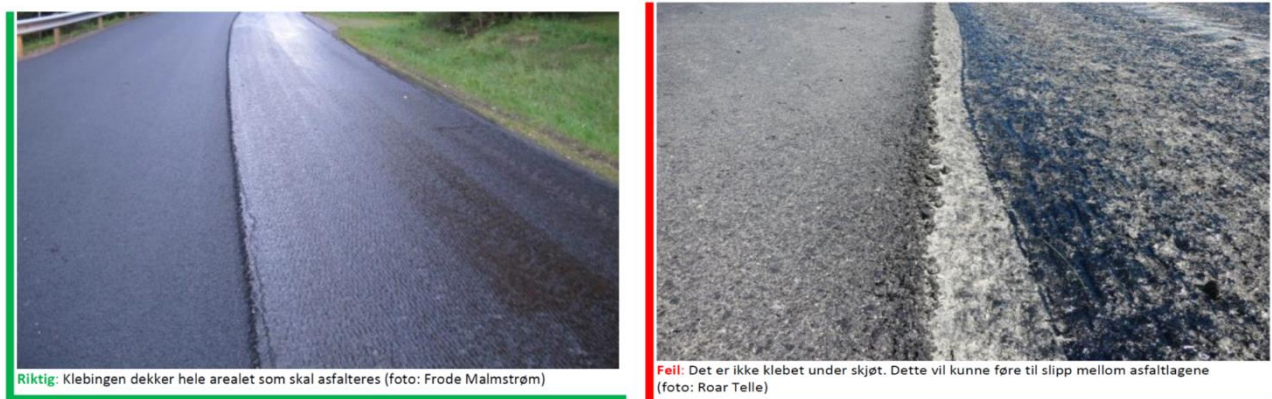
Figure 12: Example from Best practice guide; use of tack coat. Correct (left) and wrong (right) application.

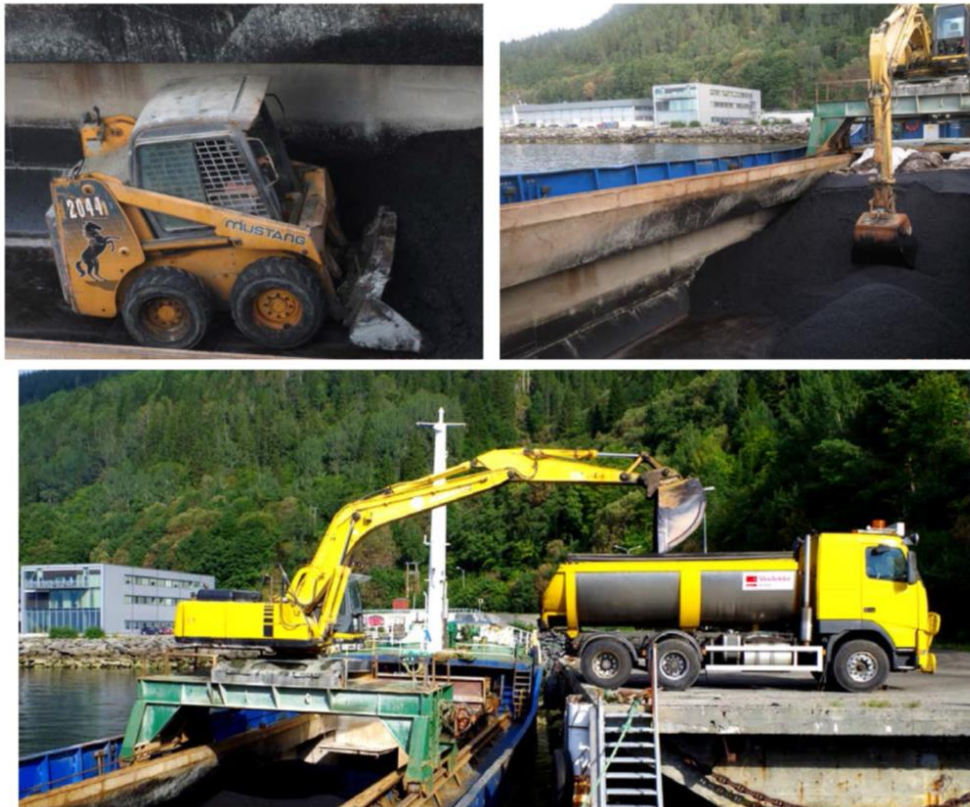
Figure 14: Examples from guidelines of asphalt transport by boat: Cold asphalt from bottom and edges of the loading room must not be loaded on one single truck. And the truck should be perpendicular to the side of the boat during unloading to prevent segregation.

“Durable roads” has done a number of follow-up studies on asphalt transport by boat, including infrared monitoring of the mix all the way from the plant, via loading on the boat, boat transport, reloading from boat to trucks, truck transport, and on to the paver at the final destination. It has been proved that loading and discharging procedures, together with how the mixes are insulated during transport, clearly influence the pavement’s homogeneity, and thereby life expectancy. Based on these studies, some easy-to-read guidelines have been developed and spread to the transporters, in cooperation with the asphalt contractors. [6]

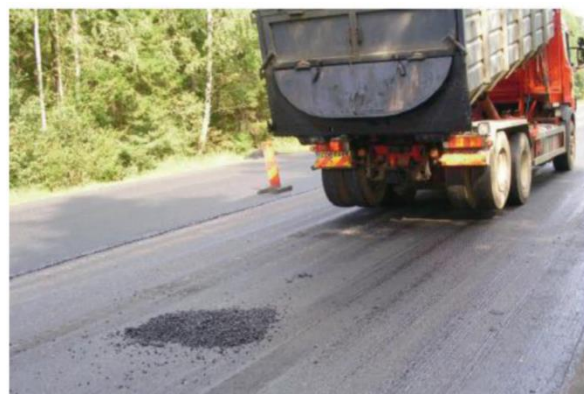
Figure 15: Examples from “Control of asphalt works”; spills from asphalt trucks shall be removed immediately, otherwise these will cause potholes.

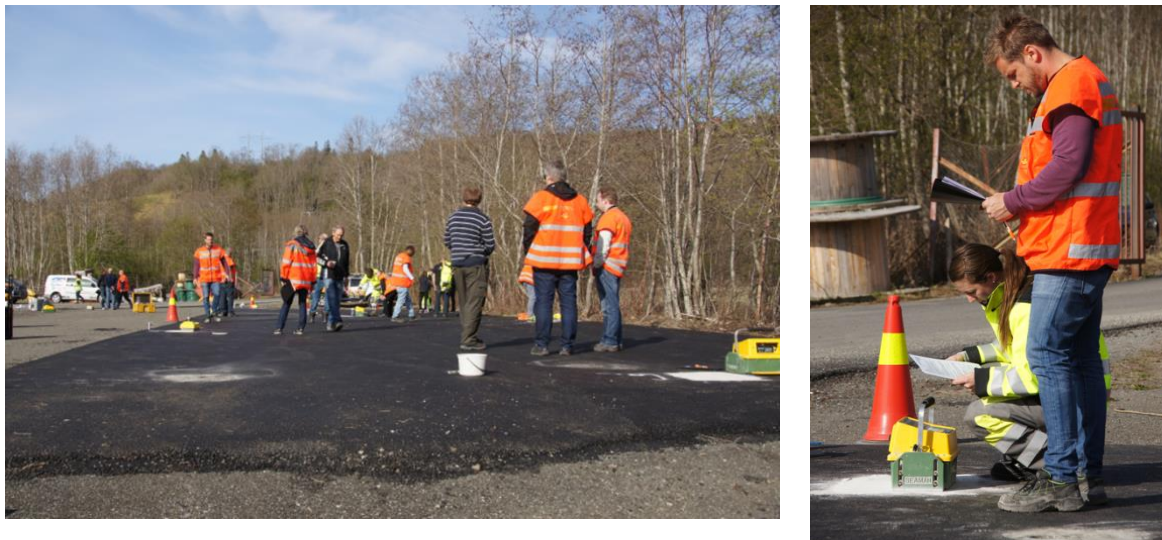
Figure 16: Asphalt inspector gathering; here comparison of asphalt density gauges.

The seminar also allows for comparison and calibration of equipment/control instruments that are to be used in the coming season, both in the field and in the laboratory, as shown in figure 16.

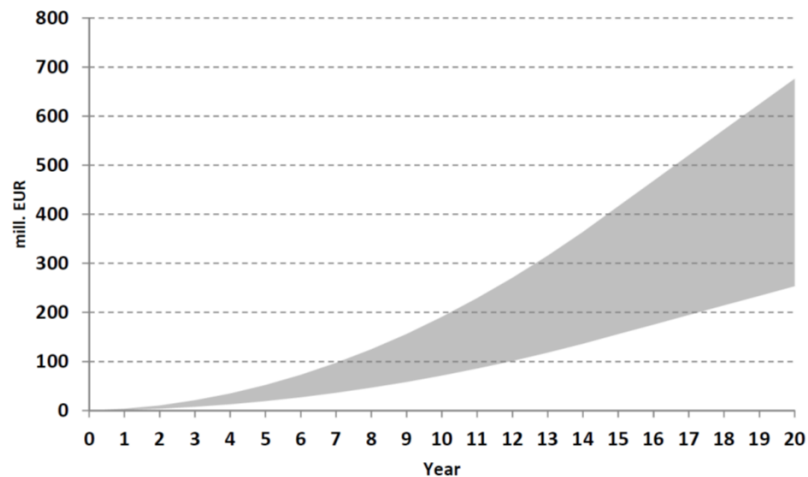
Figure 17: Potential cost savings due to improved pavement maintenance, accumulated over 20 years

Ideally, pavement service life should be the basis for the calculations. However, this information is hard to get on a detailed level, even from the National road data bank. Repaving frequency is easier to control, and should be a good substitute. Table 1 shows that the overall repaving frequency is about 15 years on the Norwegian main road network. It is expected that implementation of the project results will increase the overall service life with 1-3 years. The benefits can then be summarised as shown in table 2, given a pavement cost of 0,09 mill EUR per km. Over a period of 20 years, this gives an accumulated benefit (cost saving) in the range of 250-700 mill EUR, as shown in figure 17.
